Manhole Inspection Summary

Manhole # S13Q__002MH

Insp Date: **3/17/08 10:39 AM**

Location Address: **2839 Strickland Street**

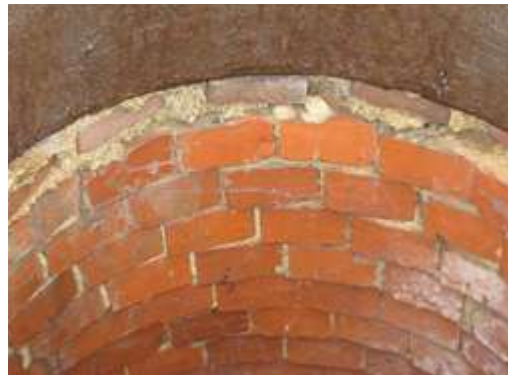
Defect 3

Condition: ☐ Sound ☐ Cracked ☐ Root Intrusion ☒ **Loose Brick** ☐ Deteriorated

chimney cond loose bricks

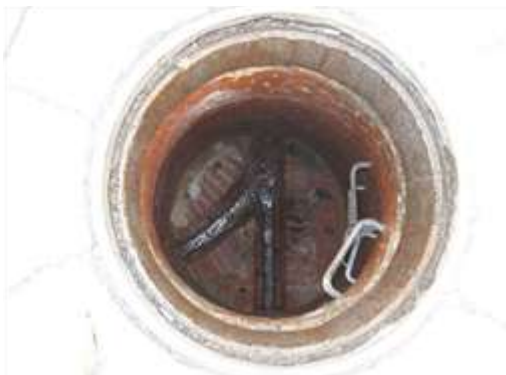
Defect 4

☒ **Leaks**

frame infiltration evidence

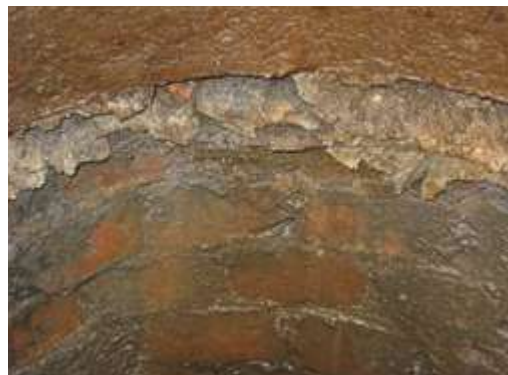
Defect 2

Infiltration: ☐ None ☒ **Joint** ☐ Cracks ☐ Mortar ☐ Roots ☐ Wall

infiltration in chimney gap

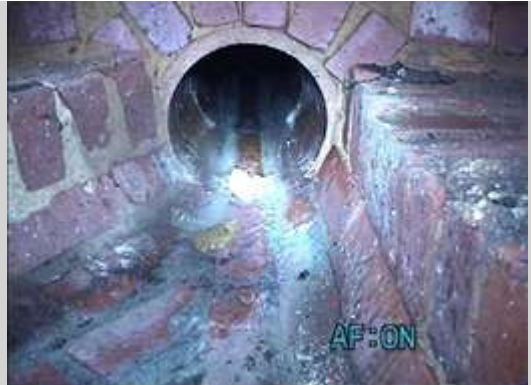
12 O'Clock Outflow

Pipe Height: **8.4** (in.) Rod and Bar (Angled)
Pipe Material: **Clay** ☐ Pipe Lined
Invert Depth: **9.54** (ft.) Flow Characteristics: **Slow**
Deposits: ☒ None ☐ Mud ☐ Sludge ☐ Debris ☐ Grease
Silt Depth: **0** (in.) Deposits Extent:
Infiltration: **None** Pipe Seal Cond: **Sound**

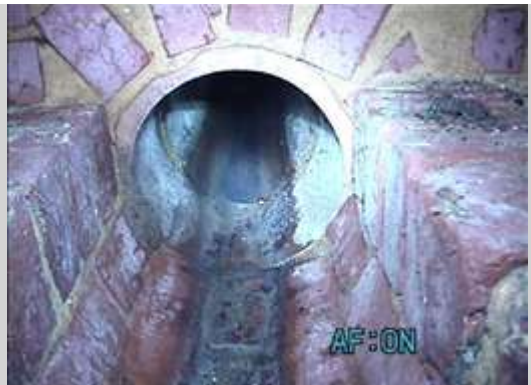
6 O'Clock Inflow

Pipe Height: **8.4** (in.) Rod and Bar (Angled)
Pipe Material: **Clay** ☐ Pipe Lined
Invert Depth: **9.32** (ft.) Flow Characteristics: **None**
Deposits: ☒ None ☐ Mud ☐ Sludge ☐ Debris ☐ Grease
Silt Depth: **0** (in.) Deposits Extent:
Infiltration: **None** Pipe Seal Cond: **Sound**

Connects To: **Stub connection / abandoned**

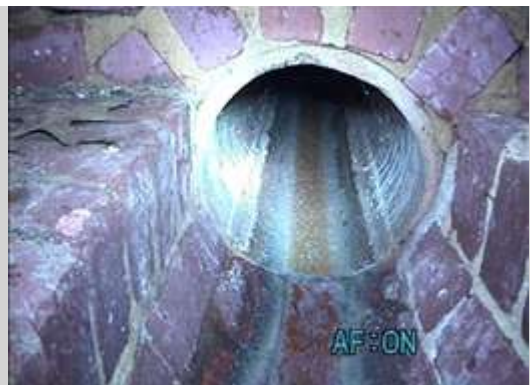
8 O'Clock Inflow

Pipe Height: **8.4** (in.) Rod and Bar (Angled)

Pipe Material: **Clay** ☐ Pipe Lined

Invert Depth: **9.32** (ft.) Flow Characteristics: **Slow**

Infiltration: **None** Pipe Seal Cond: **Sound**
